INNOVATIVE ROOT REPAIR STRATEGIES FOR WIND GENERATOR BLADES: FROM FAILURE ANALYSIS TO PRATICAL IMPLEMENTATION

2. G97T BLADE ROOT FAILURE CASE: A ROOT-CAUSE ANALYSIS

This section delves into a root cause analysis (RCA) of a particular 47.6m blade root failure produced by bushing detachment. The study involves a series of post-failure processes, where parts of the blade, particularly the root region, are extracted to examine “under the skin” the origins of the failure. The blades, located at a wind farm in Ceará-Brasil owned by AES-Brasil, and their technical details are strictly confidential then reserved for the scope of this article. Detailed and strategic information were avoided in order to comply with customer NDA.

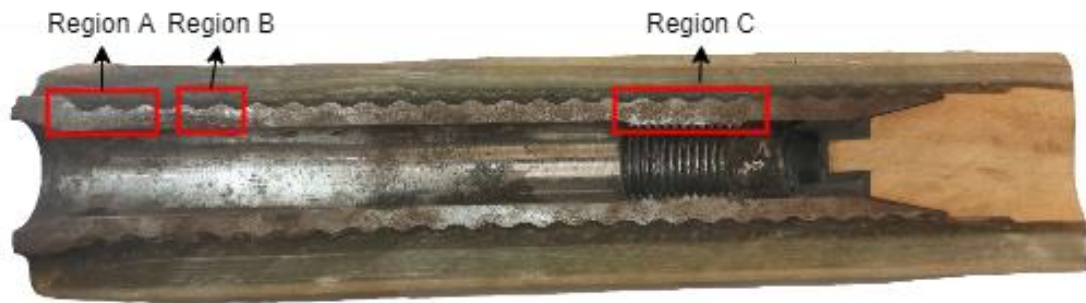
Figure 1: Post-failure cut sample of blade root

A sample from the root region, as shown in Figure 1, was the subject of the study and the initial step involved a visual inspection to check for evidence of fractures.

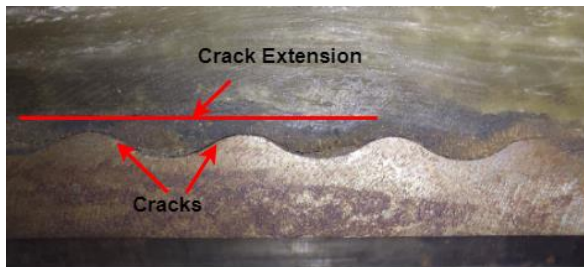
(a) Region A

Figure 2: Cracks presence in the root sample

Figure 2 revealed significant evidence of fatigue-promoted failure because of the cracks. These cracks are a common yet dangerous phenomenon known as intralaminar cracks. They typically nucleate in high-stress areas, possibly due to preload, and are often undetectable by conventional methods. They are particularly hazardous because they become visible only when a failure occurs, which is often catastrophic depending on the propagation velocity.

Regions A, B and C, highlighted in figure 6 by a red box, are depicted zoomed in the Figure 2a, 2b and 2c, respectively. In the region A can be evidenced intralaminar crack, starting at the stress concentration point (beginning of the striction zone) and developed along the waviness of the insert. Regions B and C are, indeed, similar cases.

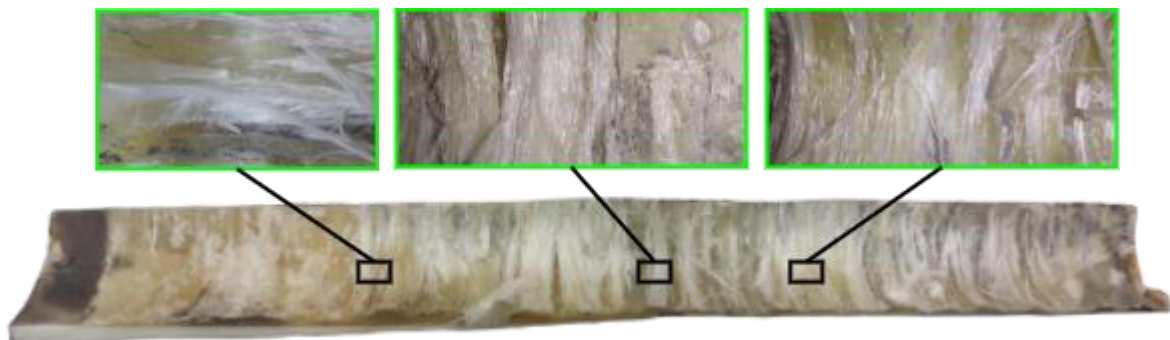
The degradation of mechanical properties can be explained by poor manufacturing quality, characterized by dry out of fibers resulting in voids and debondings. These phenomena likely took place during the blade/root manufacture due to insufficient resin impregnation. These defects naturally, as aforementioned in section 1, lead to decreased strengths and stiffness. Compression Young's modulus in the fiber direction and matrix-dominated properties are severely reduced (50% or more reduction) due to the found voids.

Figure 3: Dry out of uniaxially oriented roving around root steel insert.

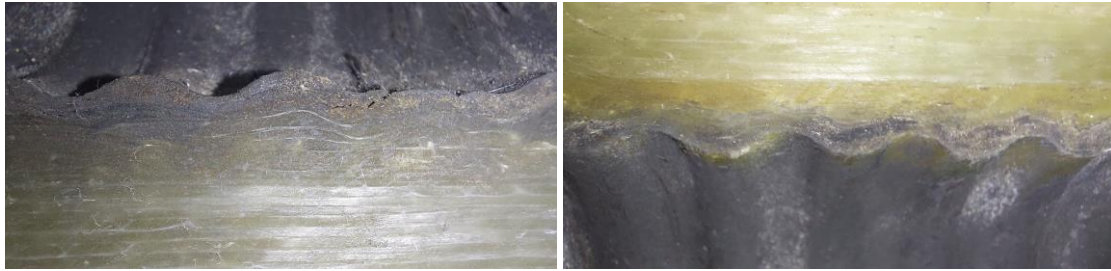
Additionally, certain regions exhibited oil contamination from the generator hydraulic system, as seen in Figure 4. This contamination is exacerbated by the high porosity of the matrix and the presence of cracks or delamination, which facilitate fluid migration. Under cyclic loading, the presence of oil may introduce additional loads in the radial root direction, worsening delamination and promoting crack propagation. This condition weakens the material, resulting in reduced strength and rendering it incapable of withstanding the design loads.

Figure 4: Oil contamination among layers and through the cracks

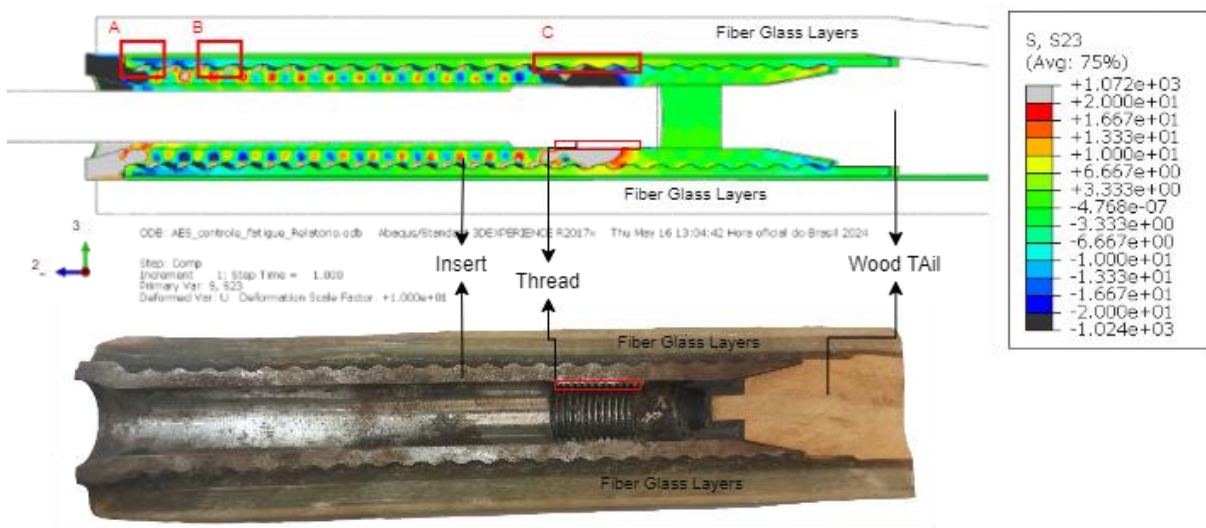
Having built the model, it was found that there is a critical stress direction, with the highest stress level occurring where the out-of-plane shear (S_{23}) is maximum. These regions, highlighted in the Figure 6, represent ideal candidates for crack nucleation or failure. As expected, when this distribution is compared with the root sample, we observe that the maximum stress values in the FEM results correspond to the locations of the cracks observed in the studied sample.

Figure 6: Stress concentrator regions in the model and crack regions in the sample

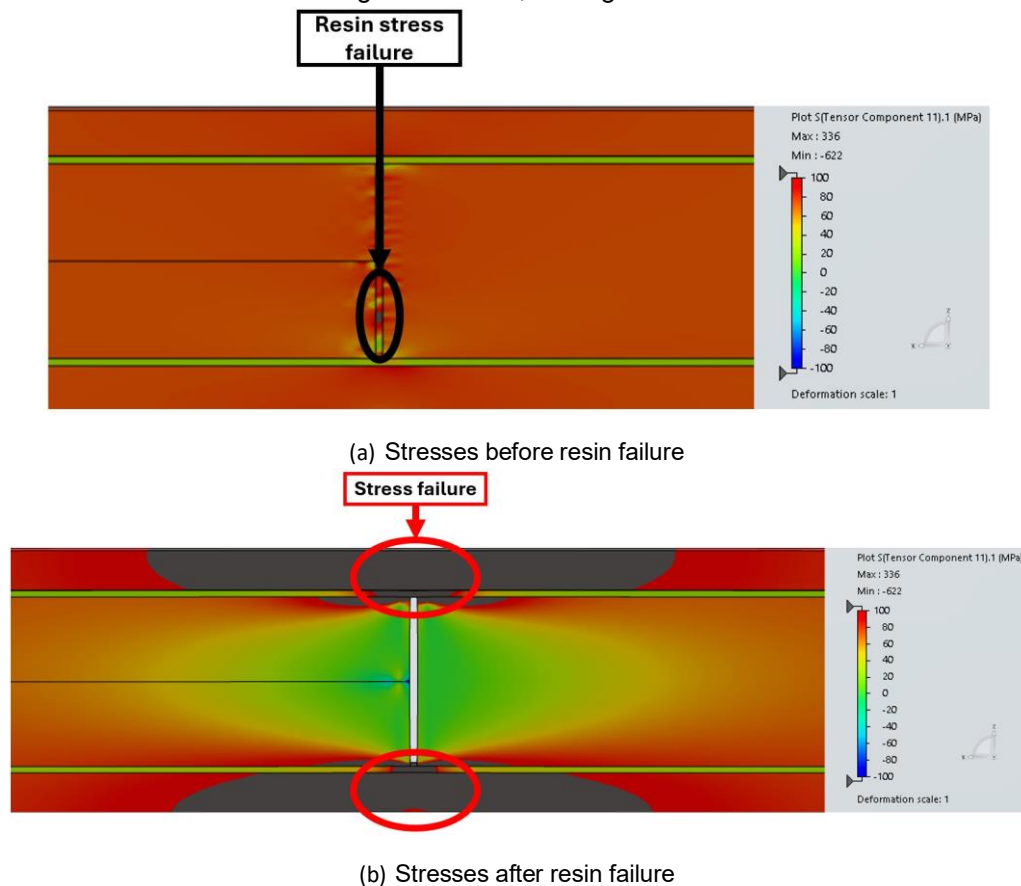
As presented in Figure 9, a possible attachment without bevel creates a huge stress concentration area, also the interface between the root and blade as creates another stress concentration area and a possible excess resin to fill the gaps, which would demand an even thicker reinforcement at the patch region, to overcome the stress concentration, indicating that the bevel could be a more efficient and safety solution. Figure 9a shows the stresses in the FEA model of attachment area before the failure of resin and the Figure 9b show the stress field of the attachment without resin. The stress level, even with a thick reinforcement laminate is above the fatigue allowable, turning such solution not viable.

Figure 9: FEA model stress for root index without taper

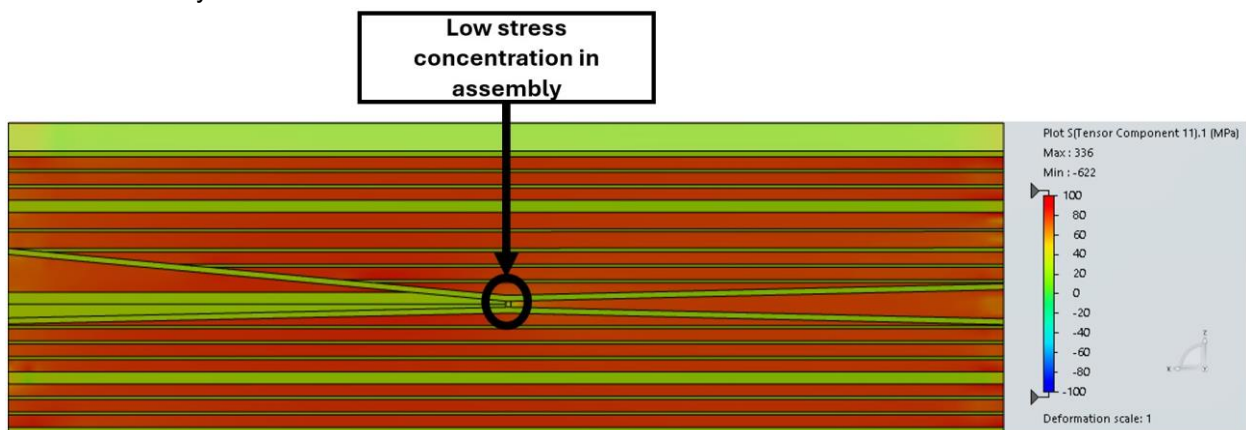
The high reliability of the procedures prompted FEA analyses of the solution. These analyses yielded satisfactory results, proving superior to the non-beveled solution. The bevels with the replacement laminate provide a more homogeneous load distribution and reduce the number of necessary laminate reinforcement layers.

Figure 11: FEA model stress for root index with taper

With better load distribution and fewer laminate reinforcement layers, the solution proved to be structurally superior and more optimized. Therefore, in-depth analyses were conducted, including coupon tests and full-scale tests, confirming the solution's integrity and its capacity to withstand fatigue stresses.
