INNOVATIVE ROOT REPAIR STRATEGIES FOR WIND GENERATOR BLADES: FROM FAILURE ANALYSIS TO PRATICAL IMPLEMENTATION

2. G97T BLADE ROOT FAILURE CASE: A ROOT-CAUSE ANALYSIS

This section delves into a root cause analysis (RCA) of a particular 47.6m blade root failure produced by bushing detachment. The study involves a series of post-failure processes, where parts of the blade, particularly the root region, are extracted to examine “under the skin” the origins of the failure. The blades, located at a wind farm in Ceará-Brasil owned by AES-Brasil, and their technical details are strictly confidential then reserved for the scope of this article. Detailed and strategic information were avoided in order to comply with customer NDA.

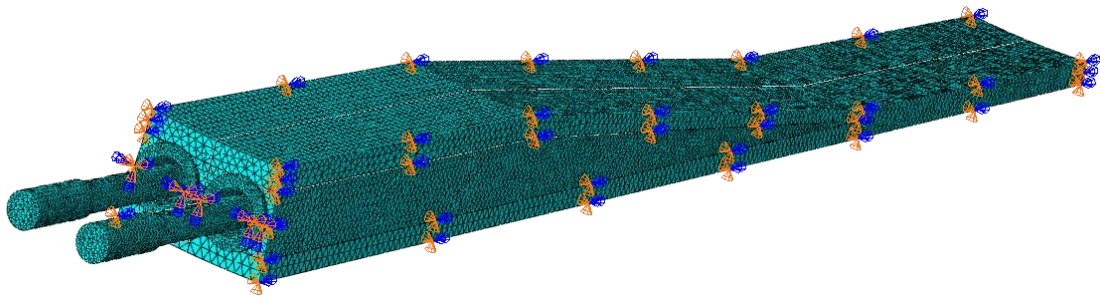
Figure 5: Finite Element Model of the original blade root

The degradation of the material properties in certain regions is evident; however, failure only occurs if the applied loads result in stresses that exceed the material's strength. Therefore, the next step in this analysis involves creating a finite element model to identify critical regions, specifically stress-concentration spots. The results of this analysis will then be compared to the **failed regions** observed in the received root sample.

Having built the model, it was found that there is a critical stress direction, with the highest stress level occurring where the out-of-plane shear (S_{23}) is maximum. These regions, highlighted in the Figure 6, represent ideal candidates for crack nucleation or failure. As expected, when this distribution is compared with the root sample, we observe that the maximum stress values in the FEM results correspond to the locations of the cracks observed in the studied sample.

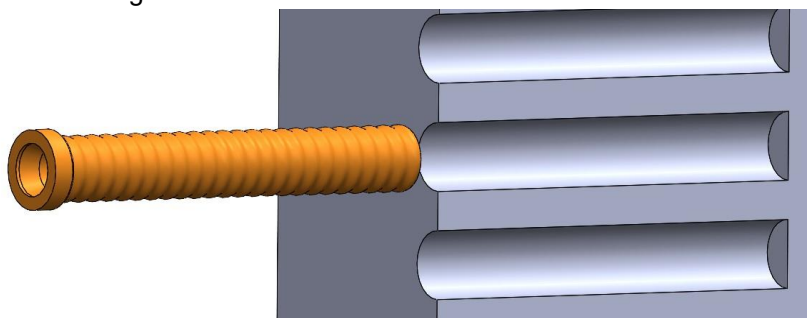
Figure 7: New insert being placed in the original blade root

The solution consists of removing the old damaged insert, either by pulling out, machining or chemical corrosion, and attaching a new insert into the root, with adhesive or with resin injection. In this case, there are no significant modifications to the composite structures of the blade root, with a new metallic insert being placed into the original root of the blade.

However, this solution has disadvantages that become impediments when considering the risks of removing damaged inserts. Three possible ways to remove the insert was studied and tested:

Therefore, ways to remove damaged inserts prove to be inefficient, risky, or too costly.

Addressing the issue of coupling new inserts to the blade root, as introduced in the root cause analysis section, the presence of porosity and microcracks in the root composite material is a widespread problem in wind blades. Porosity and microcracks are difficult and costly to detect, such that, even with strict quality control, their inspection presents a high level of inaccuracy, not achieving acceptable safety for a blade repair project. Oil absorption in the micro-cracks and porosity worsens the problem, as the presence of oil would prevent a strong bond between the new insert and the blade root.

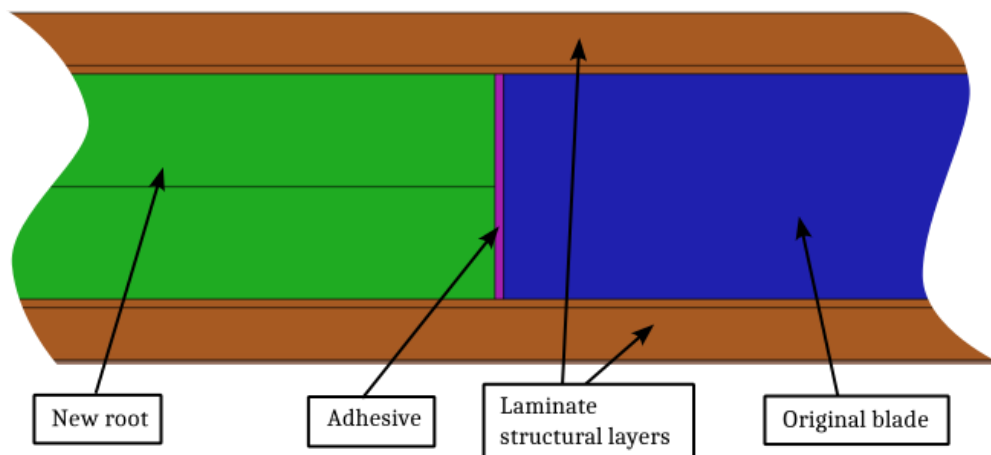
Figure 8: Root replacement attachment without bevel

The solution of replacing the root without applying a bevel involves removing the entire blade root through a flat cut. A new root is manufactured with new inserts and layers of fiber glass and resin. The attachment area of the new root is flat, as is the area of the blade that will join with the root. The parts are joined with butt joint adhesive, matching the blade's flat surface with the root's flat surface. New layers of laminate reinforcement are added around the repair area to increase the structural strength of the repair. The Figure 8 shows a representation of the junction of the solution.

As presented in Figure 9, a possible attachment without bevel creates a huge stress concentration area, also the interface between the root and blade as creates another stress concentration area and a possible excess resin to fill the gaps, which would demand an even thicker reinforcement at the patch region, to overcome the stress concentration, indicating that the bevel could be a more efficient and safety solution. Figure 9a shows the stresses in the FEA model of attachment area before the failure of resin and the Figure 9b show the stress field of the attachment without resin. The stress level, even with a thick reinforcement laminate is above the fatigue allowable, turning such solution not viable.

Since the solution cannot demonstrate acceptable levels of reliability in repair procedures, a more in-depth study of its feasibility became necessary. A finite element analysis (FEA) model was developed to apply ultimate loads and observe the structure's performance under stress. However, the FEA study revealed that the joint without the bevel is sub-optimal. It exhibited areas of high stress concentration and required a high number of laminate structural reinforcement layers. Even with large amount of reinforce layers, the stress concentration still present up to a not safety level for a fatigue life.

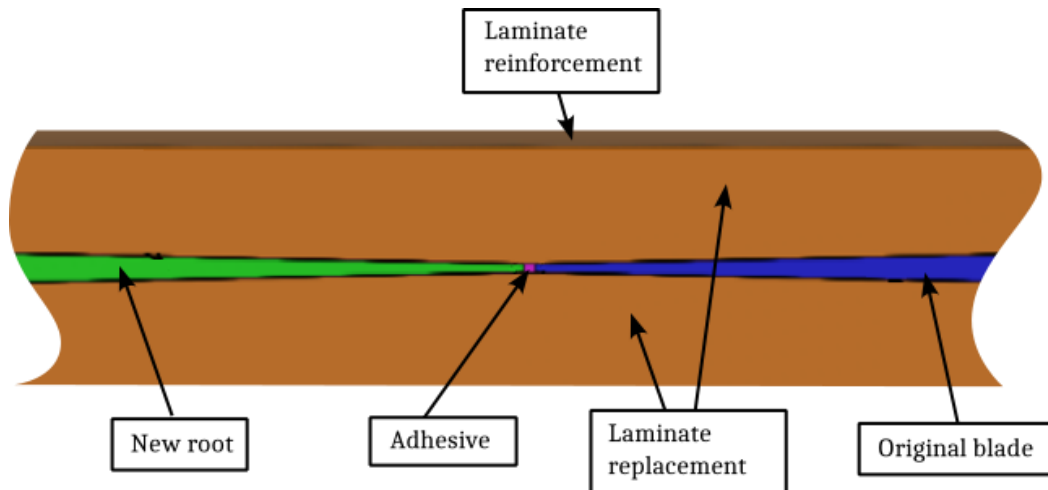
Figure 10: Root replacement junction with bevel

The bevel idea is commonly used for composite repair, which consists in machining a taper from both sides of the connection (new root and original blade) and bonding a composite for assembly, reinforcing the structure until every possible stress concentration is within safety margins from ultimate and fatigue. Figure 10 illustrates the junction region in this solution.

The reliability of this process is like the root replacement without bevel solution and superior to the insert replacement solution. The machining of bevels represents an additional step in the repair process compared to the root replacement without bevel, adding some repair time and complexity.

The high reliability of the procedures prompted FEA analyses of the solution. These analyses yielded satisfactory results, proving superior to the non-beveled solution. The bevels with the replacement laminate provide a more homogeneous load distribution and reduce the number of necessary laminate reinforcement layers.

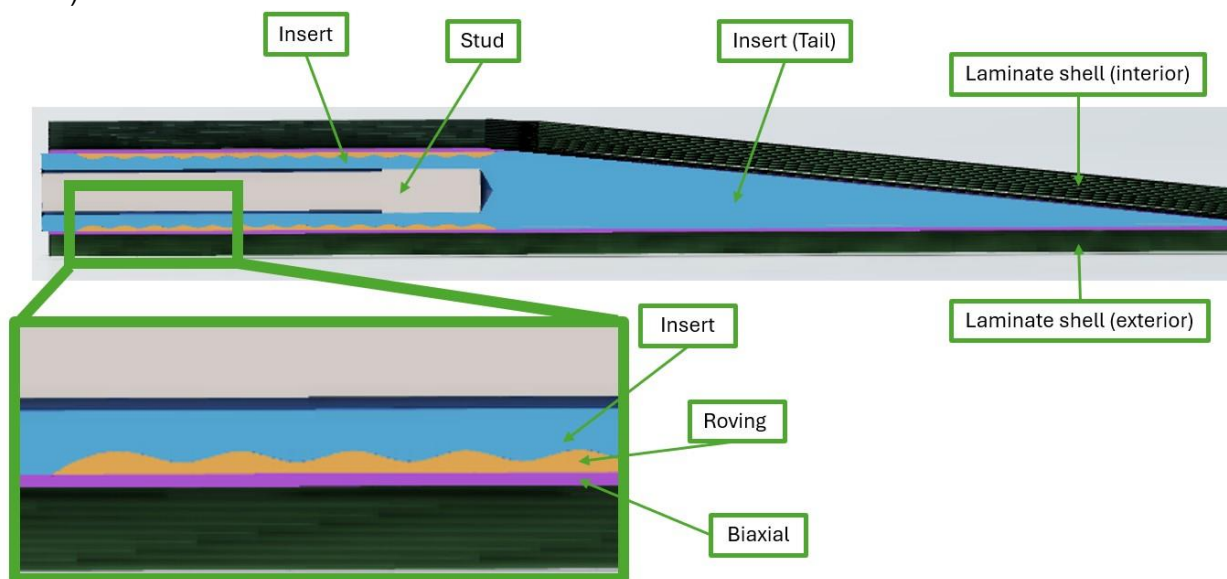
Figure 12: Insert model design in *Simulia* with section cut

The original insert, had several discontinuities and stress concentration because of composite laminate and the wooden tail interfaces. The answer to this problem was to design an insert with an embedded tail, but still including a mechanical fail safe by maintaining the ripples from the original concept, which enhances adhesion for the interface between steel and composite. (Patent Pending by NewCo Blades).

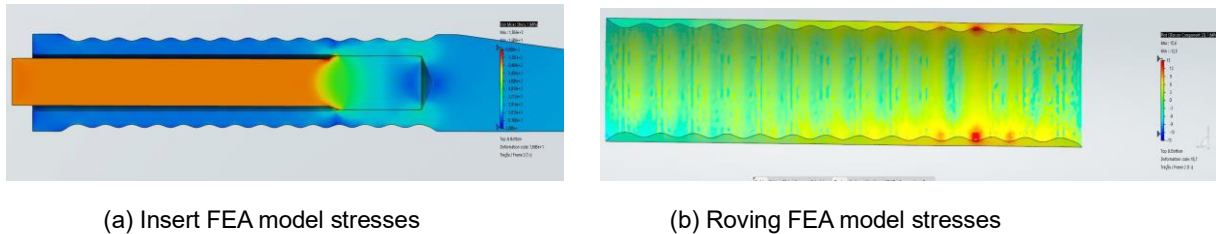
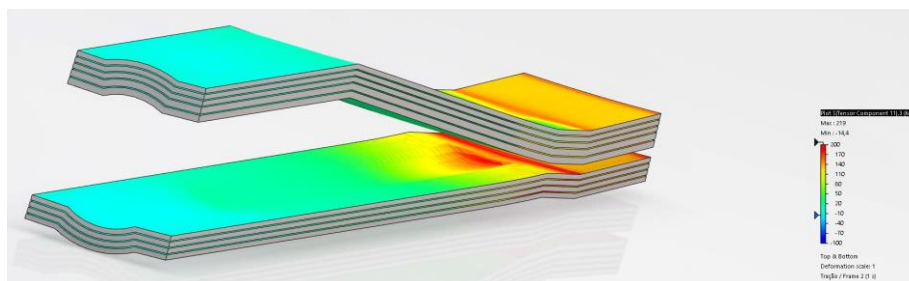
Figure 14: FEA model stress results for structural validation

Results were accessed on critical regions of the surface focusing on stress concentrations near the insert interface, where its most likely to propagate a crack and create a new failure.

For the accessed cases, all regions were able to withstand ultimate static loads while presenting a stress below the certification allowable.

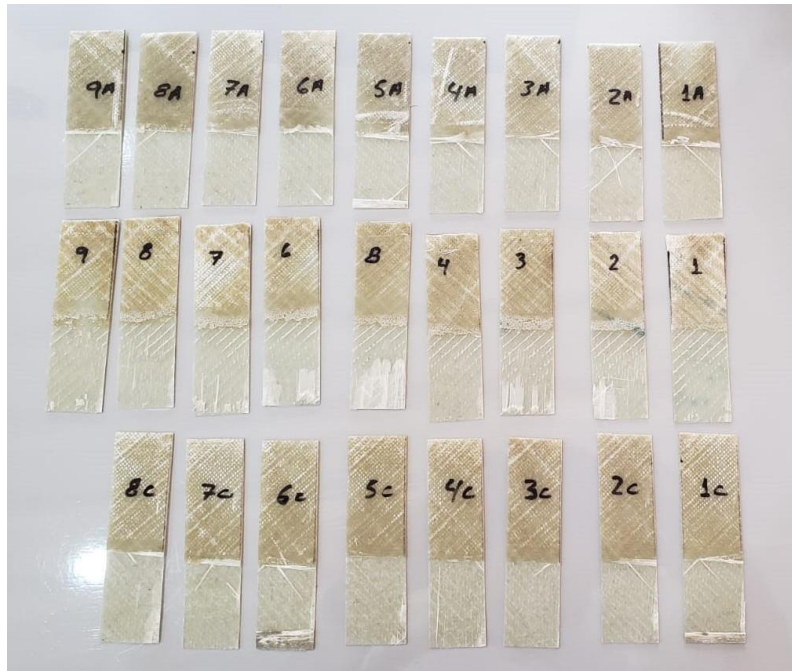
Figure 15: Lap shear test Epoxy/Polyester

Problems with adhesion between polyester and epoxy parts is the main problem to focus and an issue that reduces the stress limits for this solution. This comes from the original blade, built entirely of polyester resin, and the new root, as reinforce laminate is made entirely on epoxy.

The first way to address this problem is by optimizing the root geometry using stress limits not only from raw materials, but from adhesive tests acquired using coupons, as shown in Figure 15.

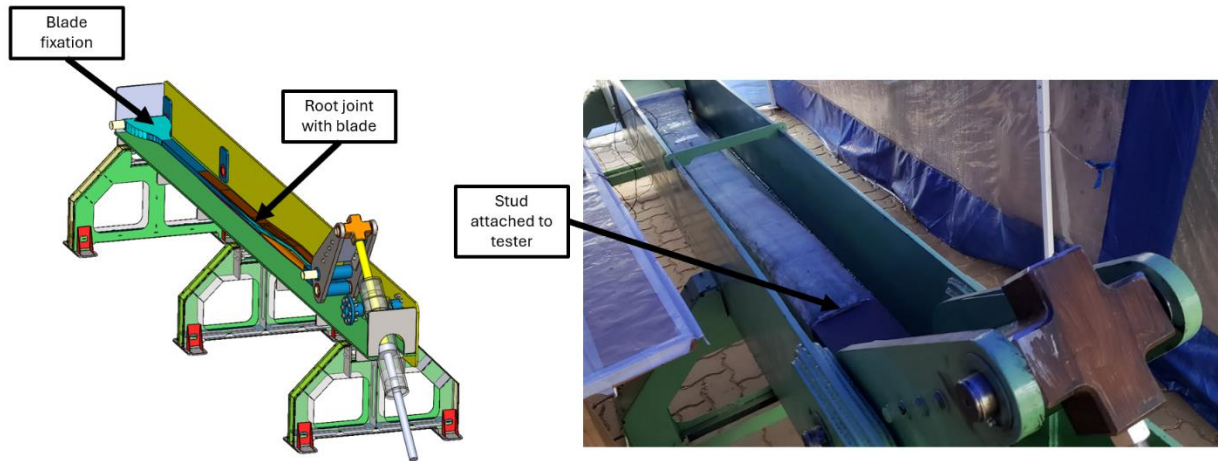
Figure 16: Component test setup

The component represents a patched root section with only one insert and it is the first set of testing to validate the design. Test results were successful with alternate cyclic forces beyond design load cases, proving that the new root is more robust than the original and concepts for this design are valid to blade repair.

The fatigue tests prove the new insert has a pulling allowable force beyond expectation, also fatigue test shown equivalent life of more than 100 years for the insert/root, and more than 20 years for the new root/old blade area interface. The results are a major upgrade from the first root replacement project done to V82. The results also make it possible to extend the blade life and therefore generator life, helping on the investment recovery for root replacement.

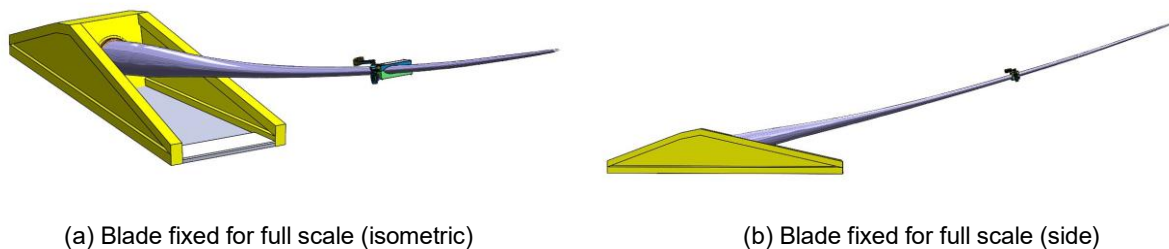
Figure 17: Fatigue tests setups

Further validation with full scale testing is being developed for this solution, generating concrete evidence that it's the safest and cheapest way to solve insert detachment failure. Other full-scale test was already developed by NewCo's team for the first design of blade root replacement on a very similar blade, but it is restricted by client contract and confidentiality terms. This first blade project already achieved more than 160 blades retrofitted without problems. Figure 17 represents the design for the tester.

Full scale testing is divided in two steps, one with a flap-wise load cycle, other being an edgewise load cycle. Combined, they produce the damage equivalent to 20 years of operation, proving that the new root is capable to withstand the whole design life of the blade without risking a whole wind turbine.
